Customer	: CC-DAR01 Dart Aerospace Ltd.	Drawing Name	: REWORK
Job Number	: 39663		
Estimate Number	: 10804		
P.O. Number	:	Part Number	: D3276041
This Issue	: 03/06/2008 S.O. No. :	Drawing Number	: NCR08-053
Prsht Rev.	: NC	Project Number	:
First Issue	: // Type : SMALL /MED FAB	Drawing Revision	:
Previous Run	: 39662	Material	:
Written By	:

Baffle Assembly LH

Qty(22) D3276-041 Baffle Assembly. The joggled tab was bent in the opposite direction from the dwg. They were all reworked to the correct the joggle (re-bent opposite). The grain directions are all at 45 degrees (not vertical per dwg). They were bent while powder coated, so it's impossible to inspect the surface of the aluminum in their current state. One baffle cracked during re-bending.

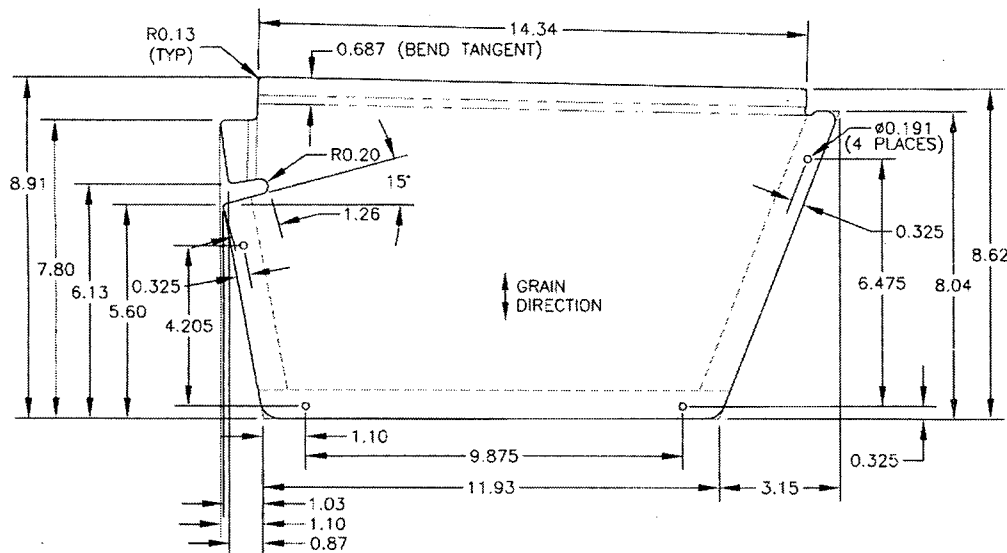
D3276-1 BAFFLE (FLAT PATTERN)

I would be inclined to accept these parts. As you mention, they will not be under any load. Also, if the tab breaks off, I have checked with Harvey, and it will fall into an area of the R44 helicopter where it will not cause any damage.

The part is bolted in, the tab is unlikely to be under any significant stress. However, I'm thinking they should maybe strip the parts (at least locally) to inspect the surface for cracks, especially since one cracked during re-bending. That probably won't be popular....

Since they were re-bent after powder, could you do an LPI to check for cracks rather than a powder removal. If the metal is cracked, the paint will also be cracked, right? If not, perhaps you could spot check a couple for cracks?
